## Global Risk Communication: A Closer Look at Infrared Thermography

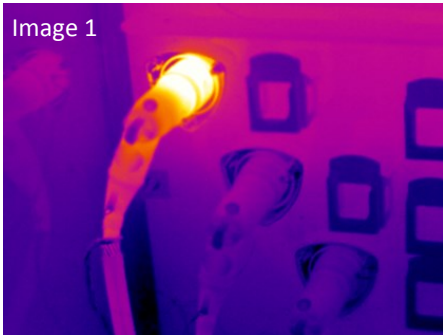
Some examples of Infrared scans are seen here. The bushing on the main transformer for a data center is seen with an elevated temperature on the H-1 main bushing which presents potential business interruption (Image 1).

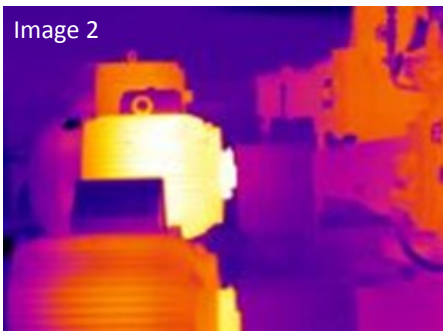
Image 2 shows an overheated motor thermal signature which could be a bearing or internal motor problem.

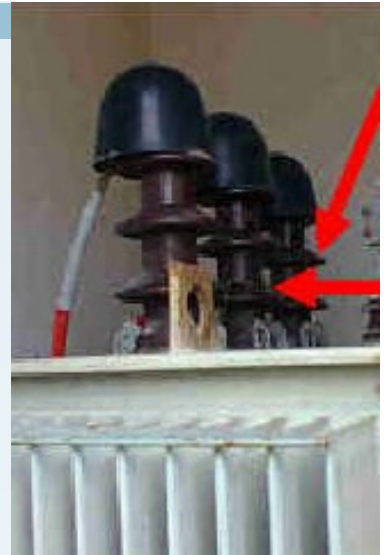
The visual in Image 3 shows 6.6kV cabling on verge of catastrophic failure due to a conductor breakdown that was detected ultrasonically. Net loss potential was \$800,000 minus the potential of injury at time of phase to phase arc flash. Action was to replace the damaged conductors and reroute as to not overlap and touch adjoining cabling.

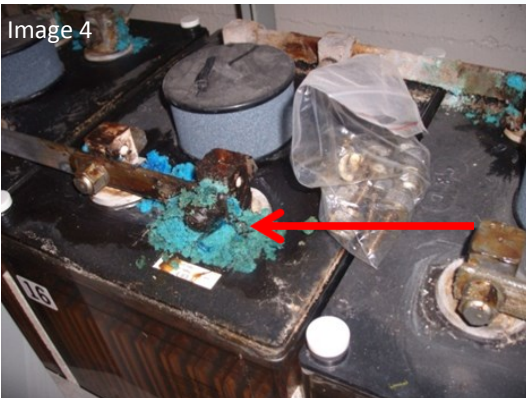
Another tried and true weapon in the loss control arsenal is neither new nor expensive, and that is visual or physical inspection, which if implemented on a consistent and professional level can be the most productive of the three techniques described. In this case (Image 4), Tripping batteries and UPS batteries are critical components in any electrical system and should have a documented visual inspection program. Image 5 shows the high side of a power company transformer that requires cleaning.
